## **Pulsarlube Solution at PA Paper Mill**

Date Installed – 12/6/2007

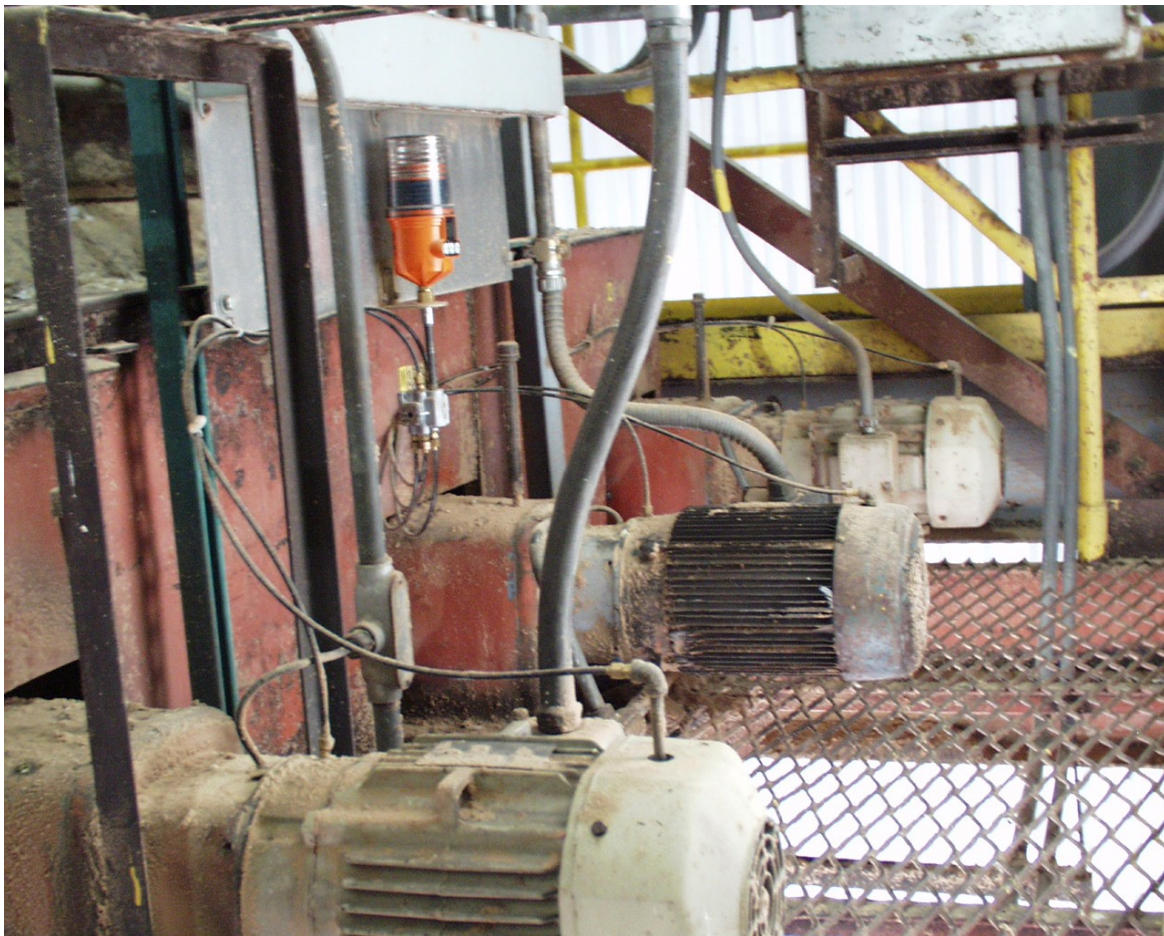
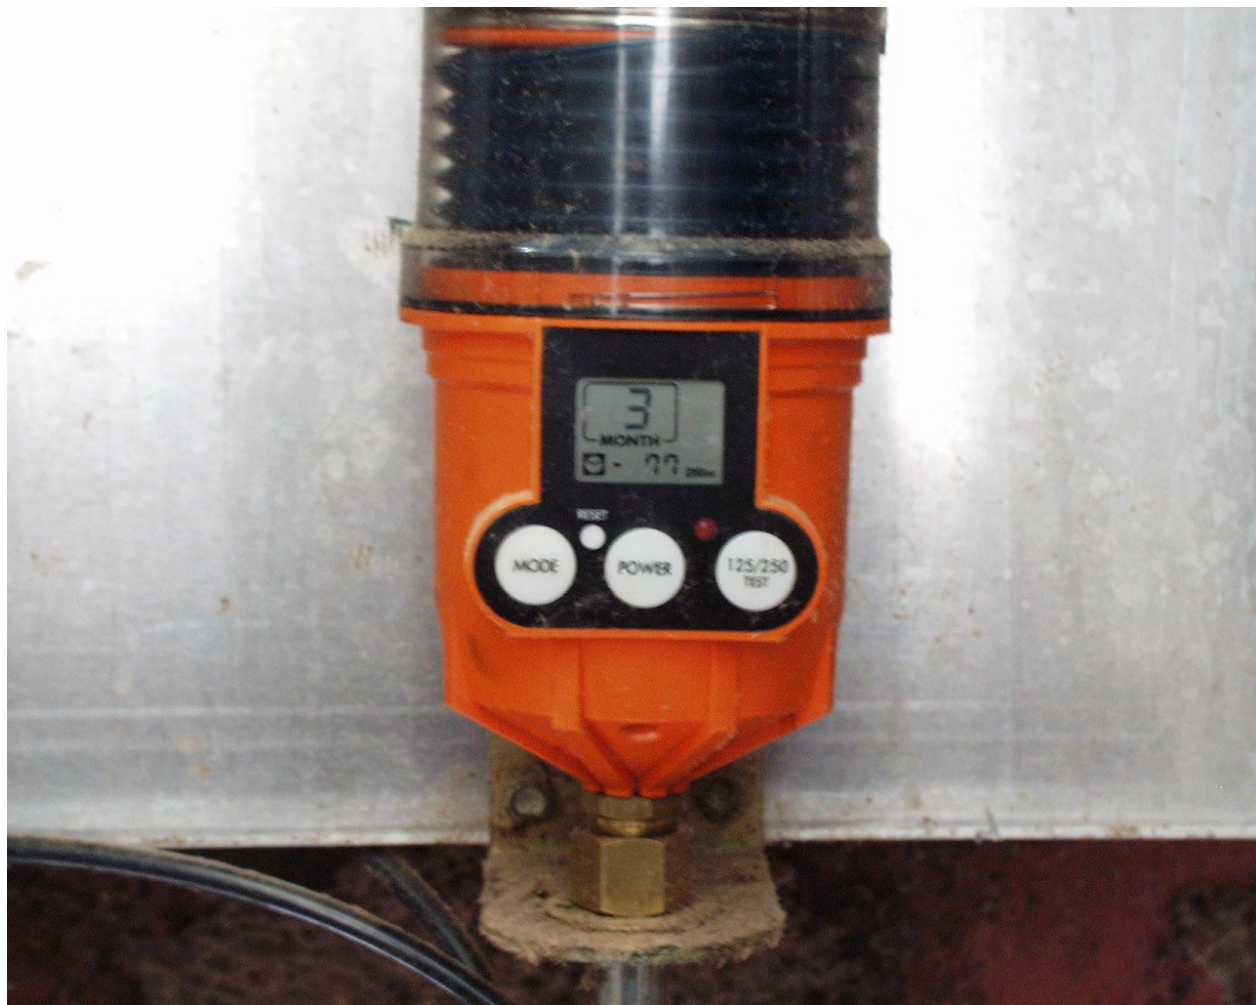
Pumps located in an obscure area of plant, subjected to outside Temperatures but pumps are under cover. Pumps suppose to get greases regularly but it does not happen. They run 24/7 and have had some failures do to dry running.

**Solution** Installed a Pulsarlube M with a six point divider block and hooked up to 3 pumps. To date there have been no problems.
